# UNITED STATES ENVIRONMENTAL PROTECTION AGENCY CATEGORICAL EXCLUSION

## Beeson Creek Stream Restoration – Reach 7

788 Beeson Road  
Kernersville, North Carolina

**United States Environmental Protection Agency  
Beeson Creek Stream Restoration – Reach 7  
Categorical Exclusion  
788 Beeson Road  
Kernersville, North Carolina  
H&H Job No. TOK.001**

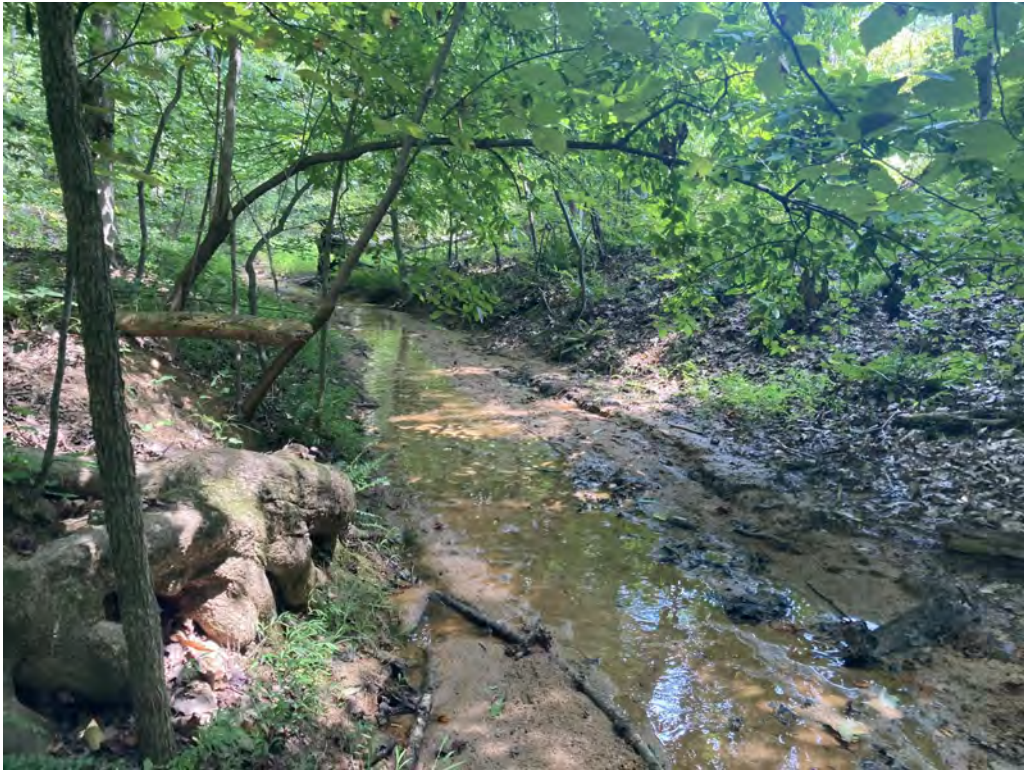
Photograph 1: General view of SCA in the south-central portion of the Site

- *Stream Channel “A” (SCA)* – originates at a large headcut in the central portion of the Site and flows southeast off-Site. H&H observed a defined OHWM, defined bed and bank, and discernable baseflow within SCA. SCA appears to intersect the water table throughout the majority of the year. H&H used the DEQ DWR Stream Identification Form (version 4.11), which indicates that SCA has characteristics consistent with that of a perennial stream. SCA totals approximately 1,067 linear feet of on-Site length.

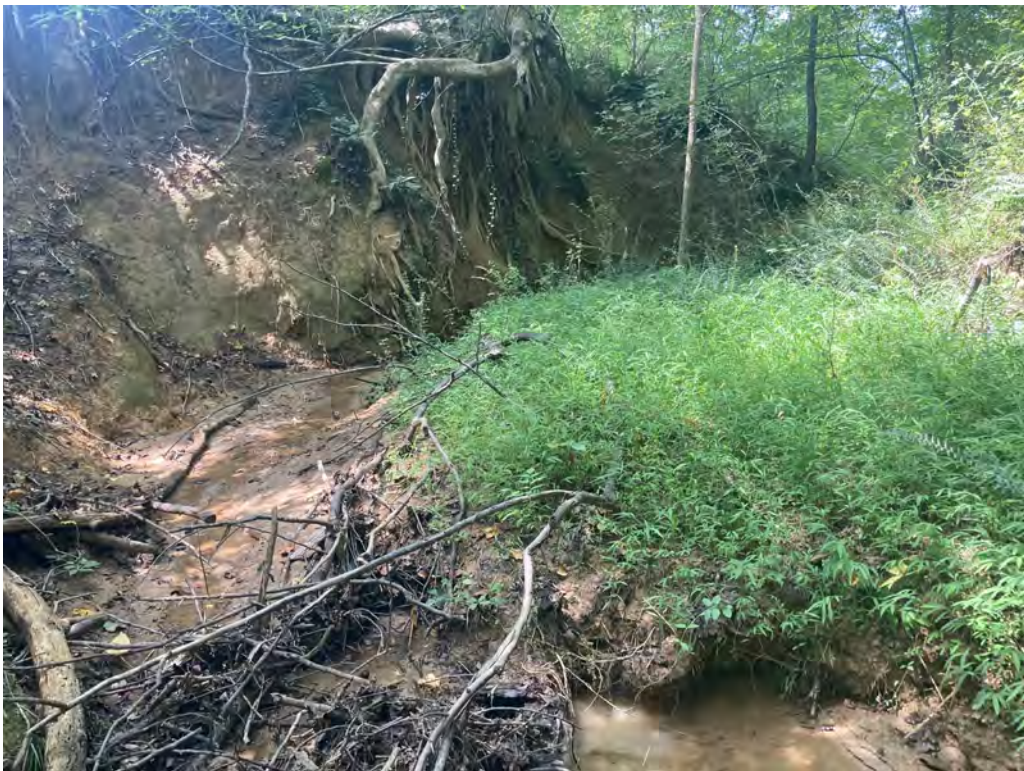
Photograph 2: General view of SCB in the central portion of the Site

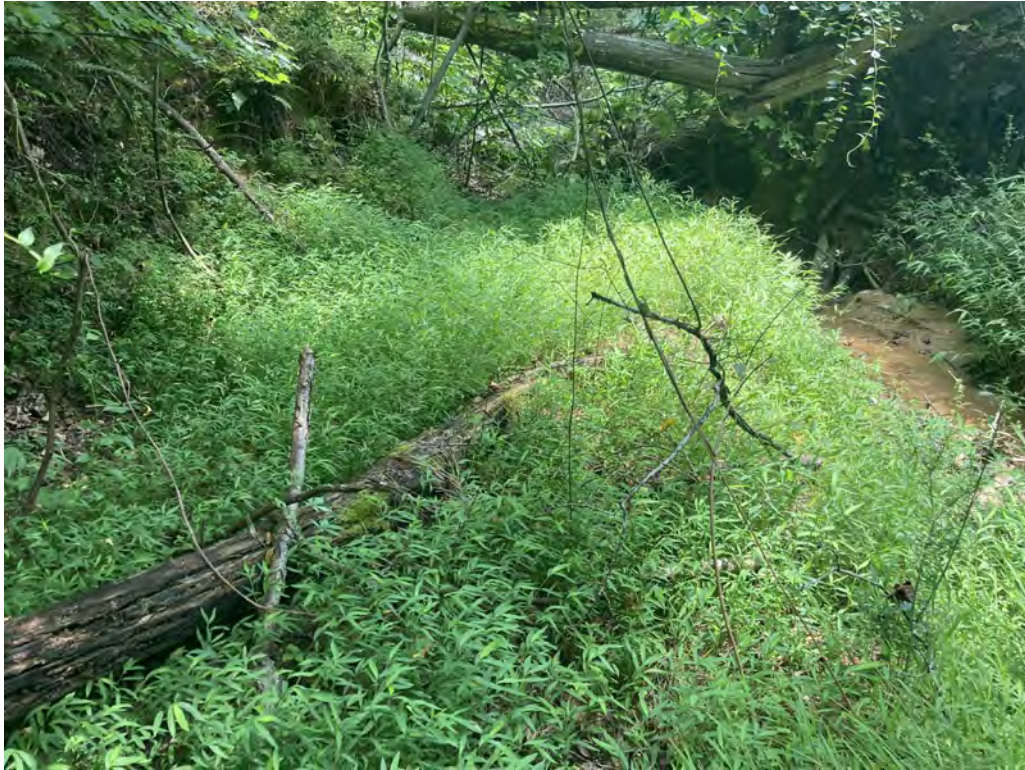
Photograph 3: General view of Wetland 'A' in the southern portion of the Site

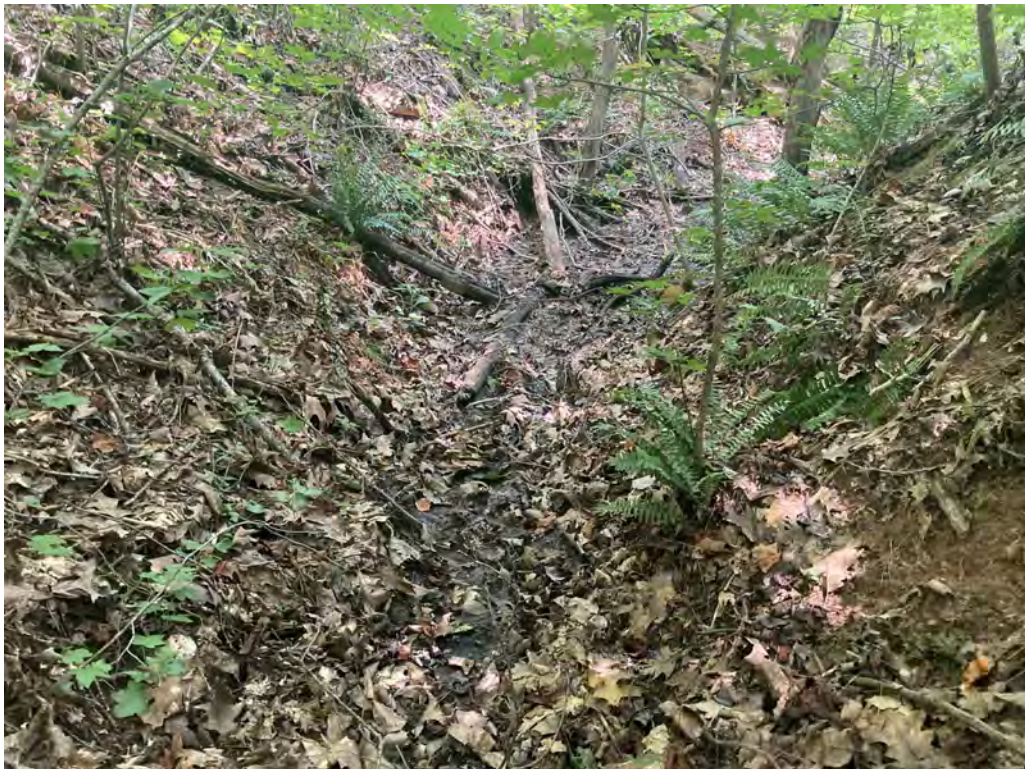
Photograph 4: General view of Wetland 'B' in the southern portion of the Site

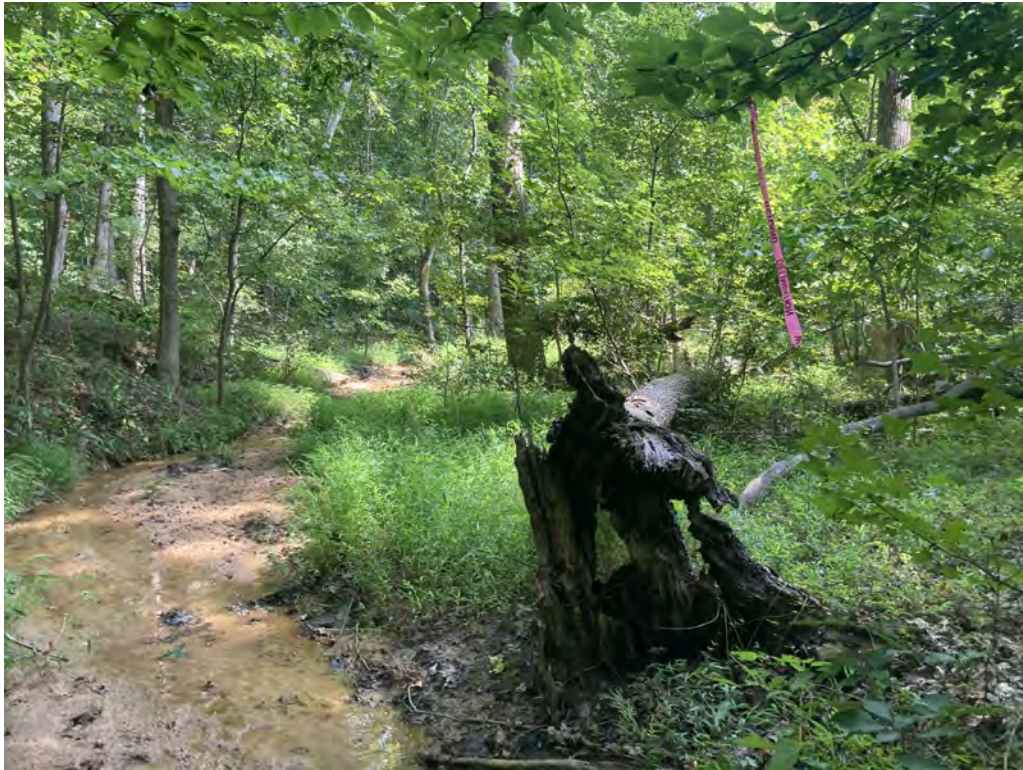
Photograph 5: General view of Wetland 'C' in the southern portion of the Site

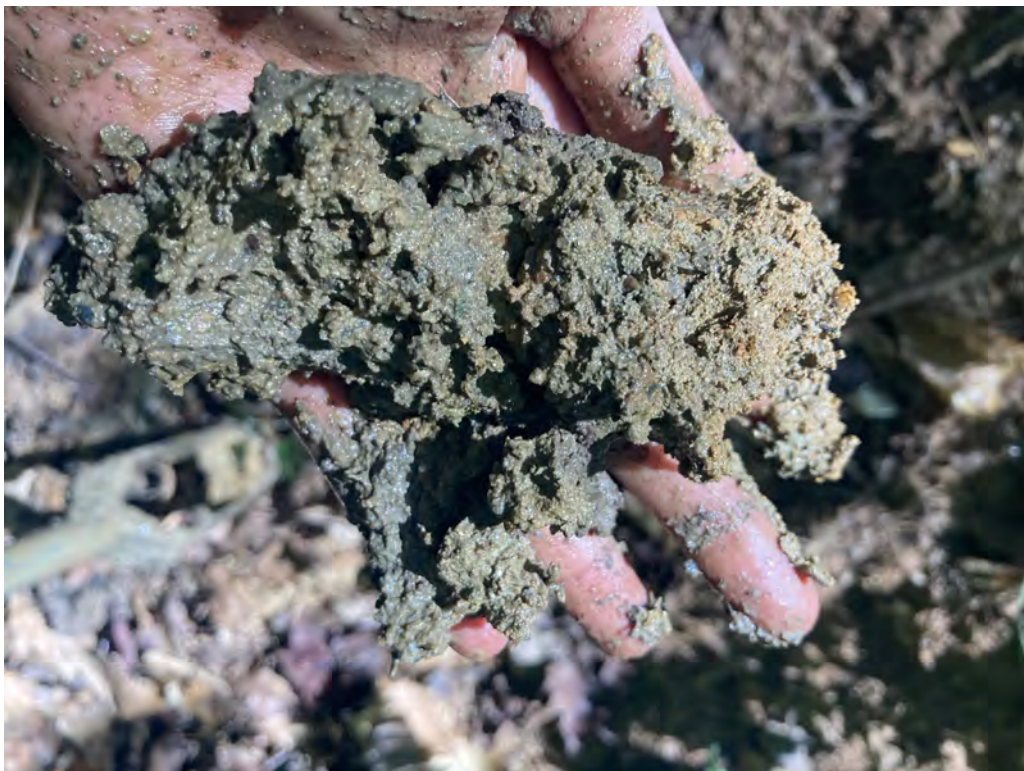
Photograph 8: Hydric soils observed in the southern portion of the Site

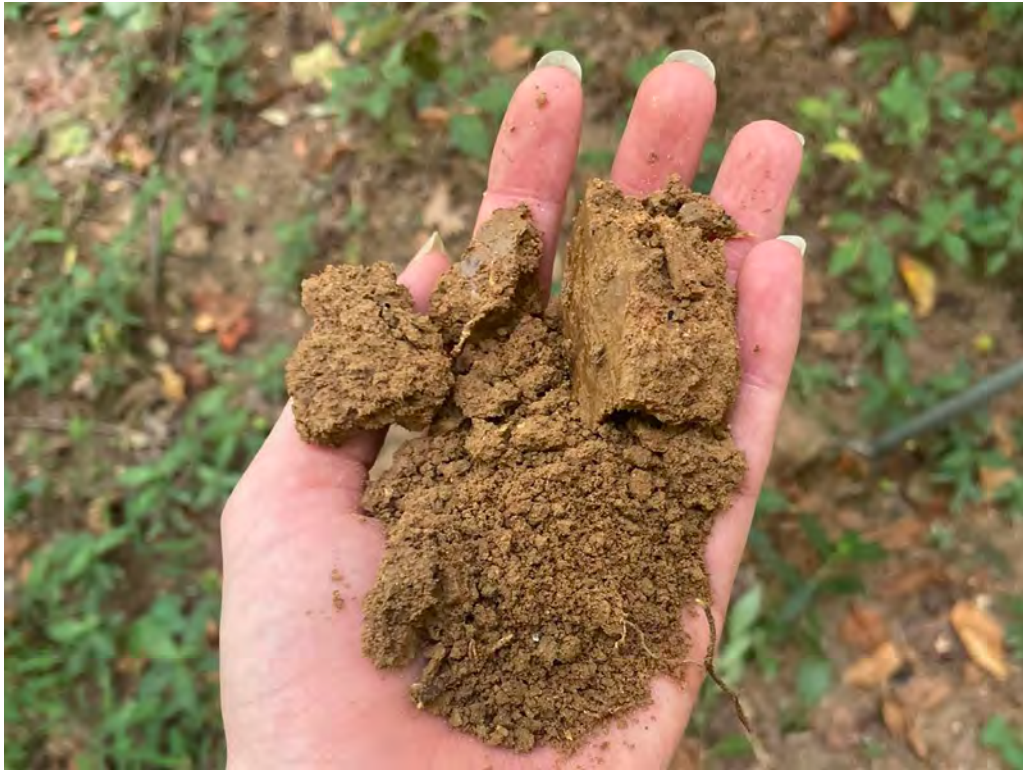
Photograph 9: Upland soils observed throughout the Site
